WRDC-TR-89-3075

FULL-SCALE BIRDSTRIKE TESTING OF IN-SERVICE
AGED F-111 ADBIRT WINDSHIELD TRANSPARENCIES

University of Dayton Research Institute
300 College Park Avenue
Dayton OH 45469

Interim Report for Period May 1985 - November 1987

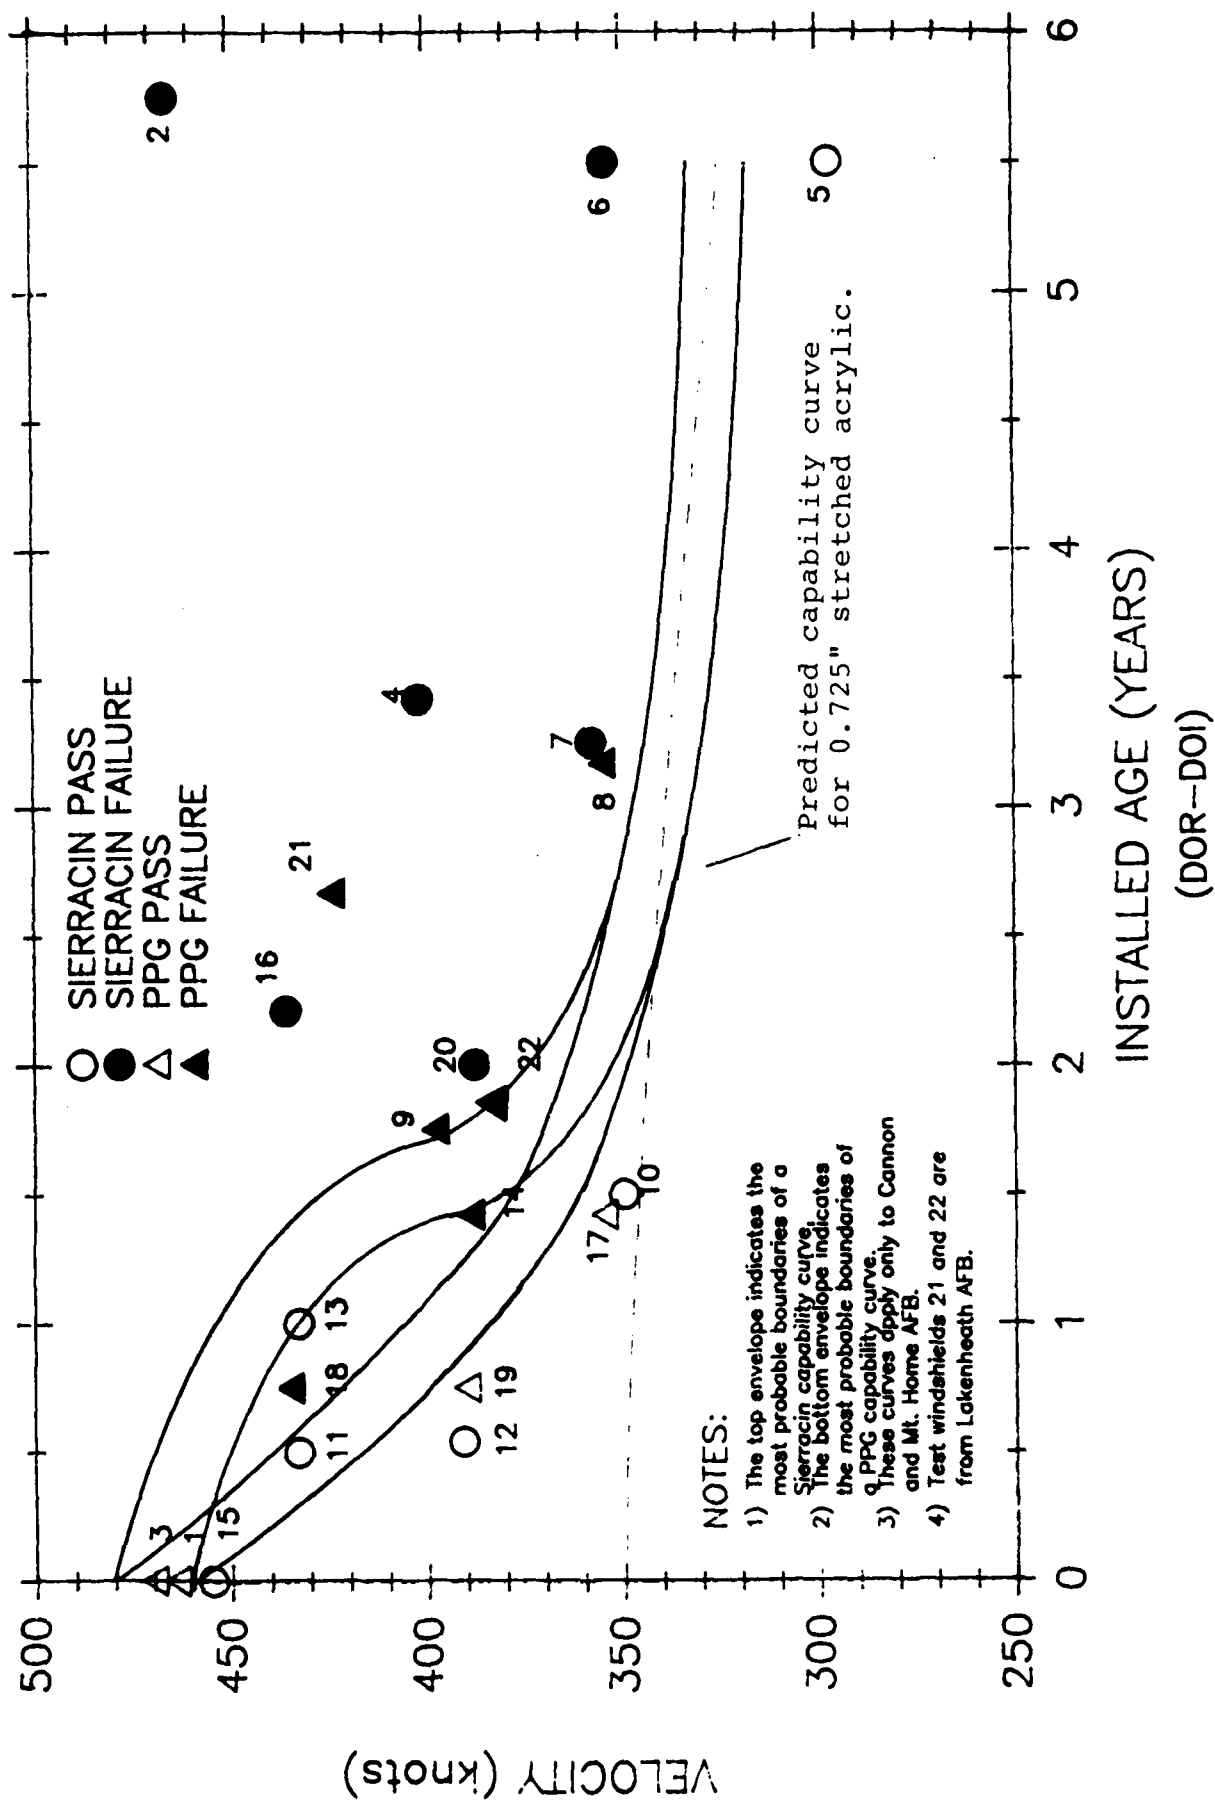
Figure 15. Capability Envelopes for Sierracin and PPG Transparencies.

degradation is related only to the date of manufacture. Figure 14 is a plot of birdstrike resistance capability versus date of manufacture. No trend is evident from this plot, although at least one source in the literature indicates a reduction in bare polycarbonate impact strength with absolute age.⁷ A plot of birdstrike resistance capability versus installed age (date of installation subtracted from date of removal) is presented for each vendor in Figure 15. (Note that a predicted capability curve for 0.725 inch stretched acrylic is included.*) This plot indicates a definite relationship between installed age and degradation. The actual cause of degradation may be a complex combination of extrinsic factors including absolute age, installed age, geographic location, and more specific intrinsic factors such as total UV exposure, thermal history, fatigue, hydrolysis, and molecular attack. Table 4 presents a comparison of baseline and in-service aged windshield birdstrike resistance.

than 1.5-2 years of installed age. For Sierracin shots 11, 13, 15, and 16, the edge attachment sheared 10-16 bolts behind the impact point without failing the edge attachment. For PPG shots 1, 3, and 18 the bolts yielded behind the impact point but did not fail, and the transparency started to tear through the bolt hole line. This difference in edge attachment performance may be partially attributed to a difference in transparency stiffness for the two vendors. The PPG transparencies appear to be more stiff than the Sierracin transparencies, accounting for lower loads transmitted to the arch; the stiffer window being a more efficient shell structure, thereby distributing the load more evenly. The less stiff Sierracin windshield allows more localized deformation and load concentration immediately behind the impact point, causing bolt failure. This bolt failure is unique to the UDRI test hardware and is attributable to flange and overall arch stiffness differences between the UDRI test hardware and the flight hardware. In addition, the canopy frame was not in intimate contact with the UDRI test aft arch, allowing more out-of-plane deformation in the UDRI aft arch than exists in the actual flight system.

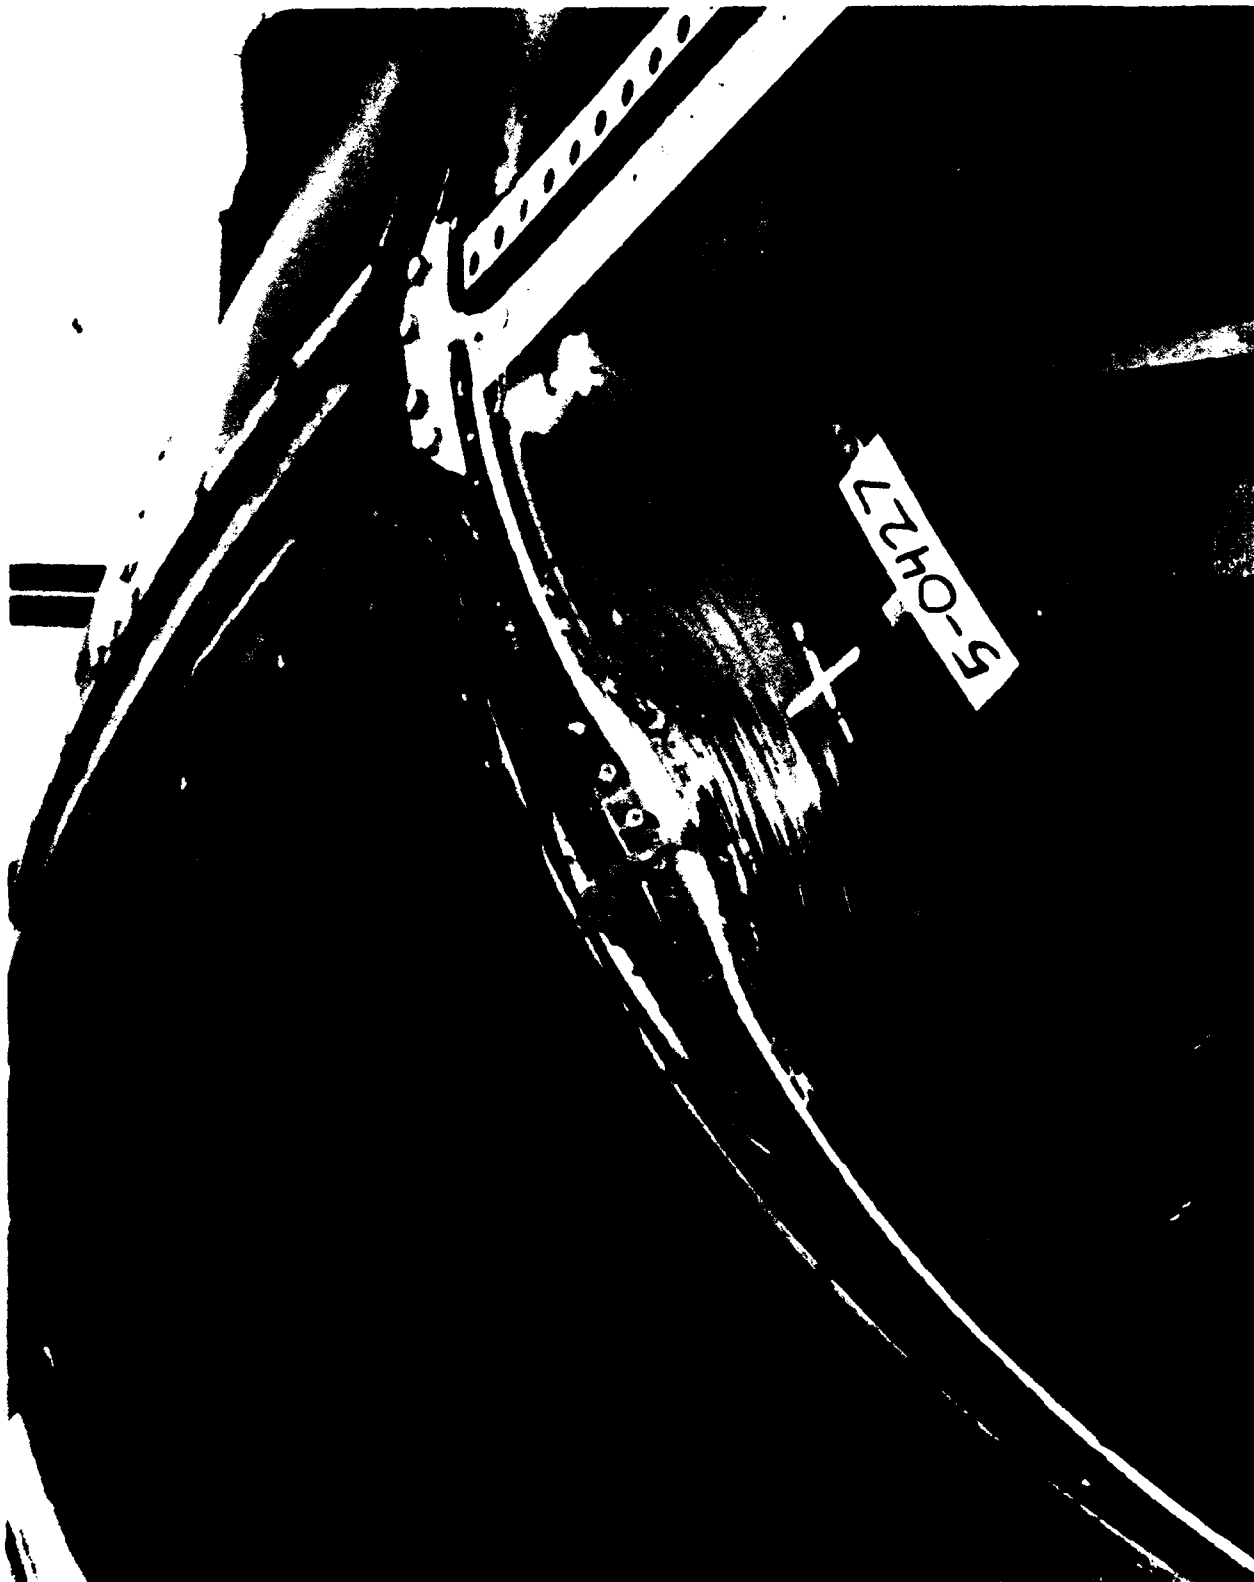
TEST NO. 1 SHOT NO. 5-0427

Forward arch flange appears to be too stiff--only very local rotation,
and not much rotation aft.
Stiffness of arch at sill appears to be too high causing excessive
side load and moment at sill
Pass - at 464 knots.

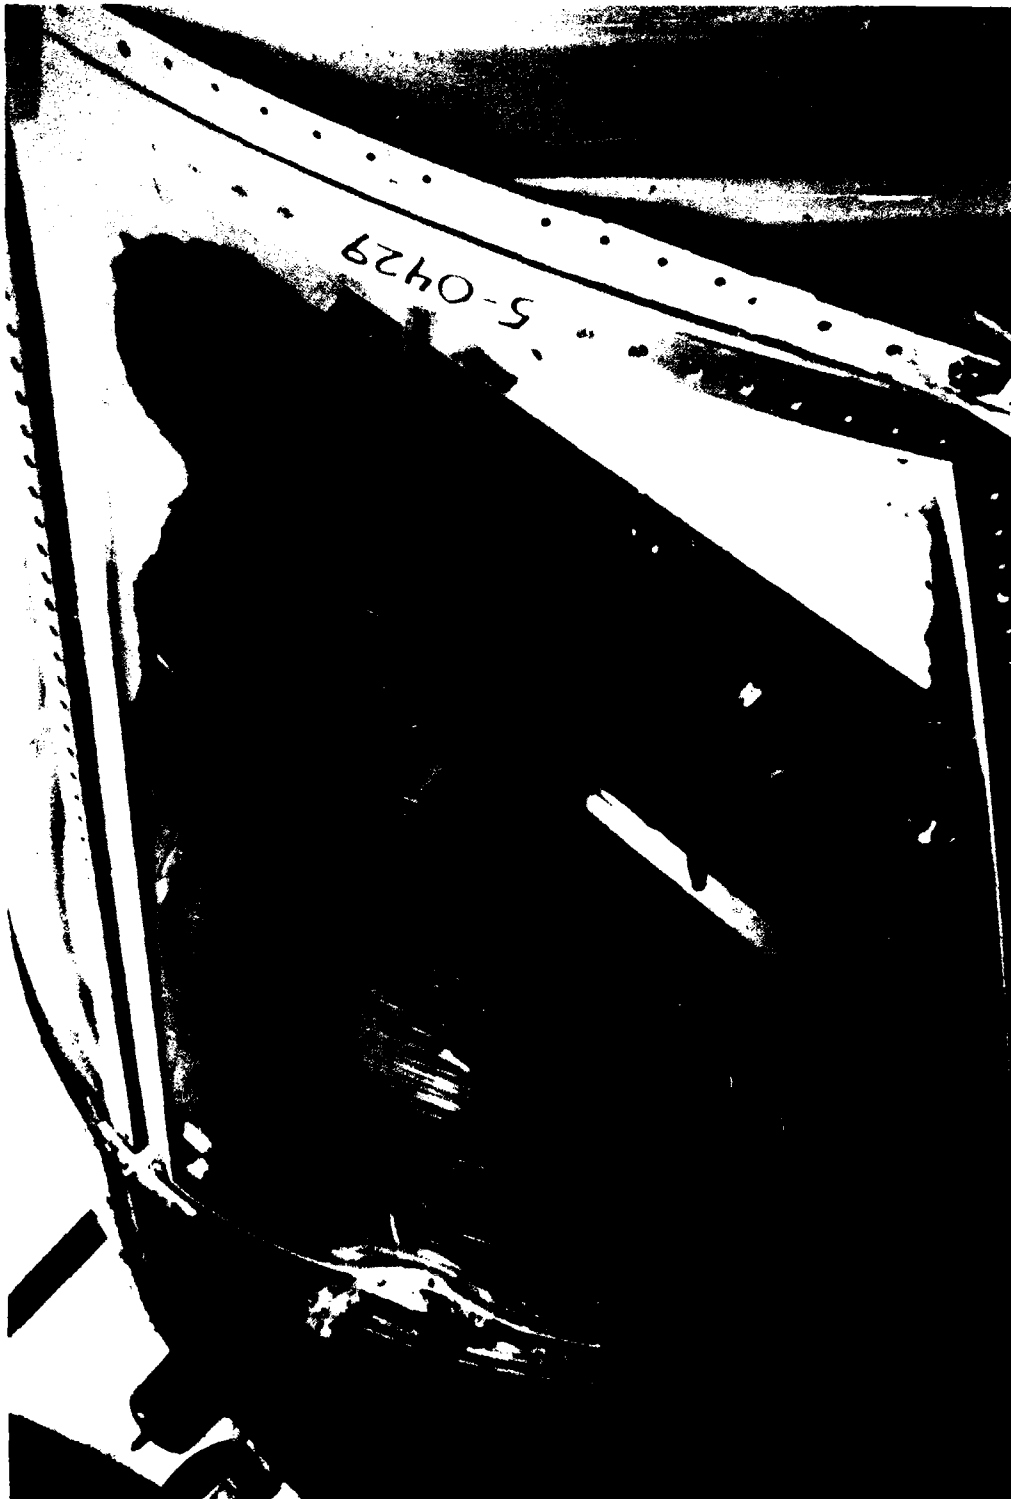
TEST NO. 3 SHOT NO. 5-0429

Unless windshield was degraded, this is the system capability.

Arch modifications satisfactory.

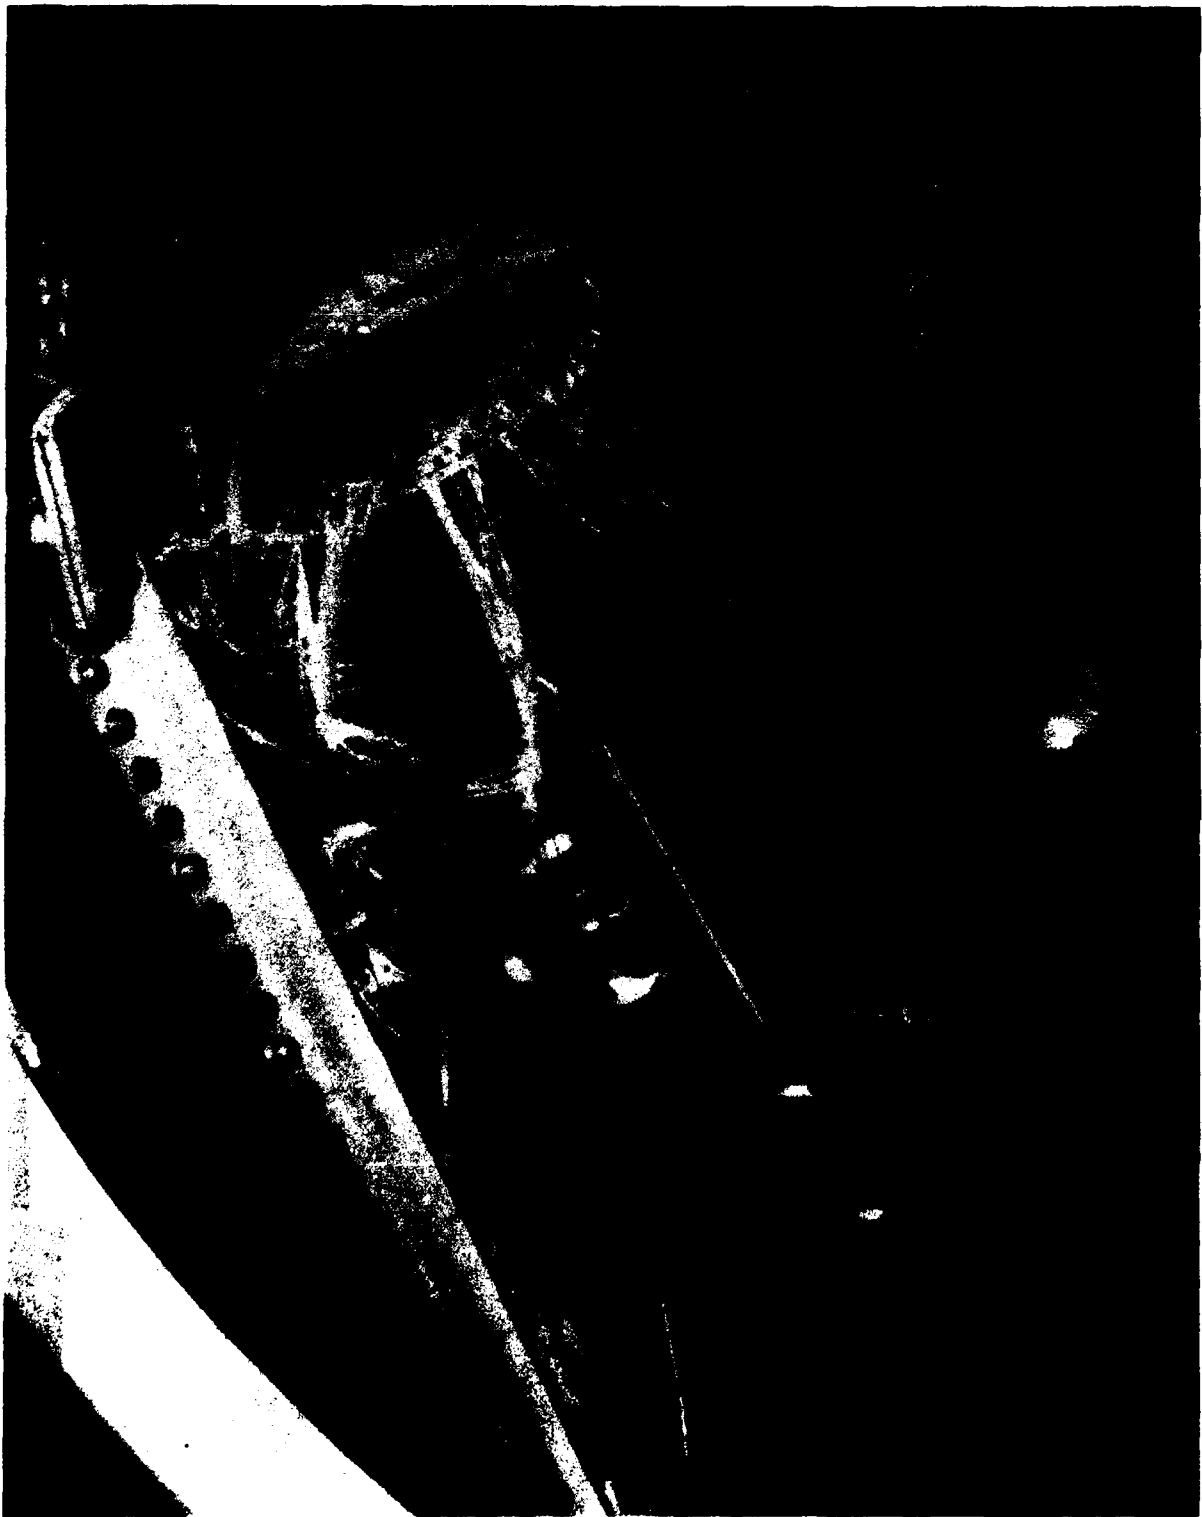
TEST NO. 18 SHOT NO. 5-0444

Fastener #1 on arch and #1 and 2 on center beam not in. Fasteners 3 and 4 on center beam replaced with #10 NAS 1203-15 screws. Windshield extremely oversized, very difficult to install--probable cause of premature in-service failure (crazing extensive), was stress on window during service. Windshield in compression at aft arch. Interior coating discolored white with scratches.

Extensive cracking of acrylic away from impact point.

Very unusual acrylic chipping at impact point caused by prestress compressive load.

No polycarbonate cracking.

Pass at 390 knots.

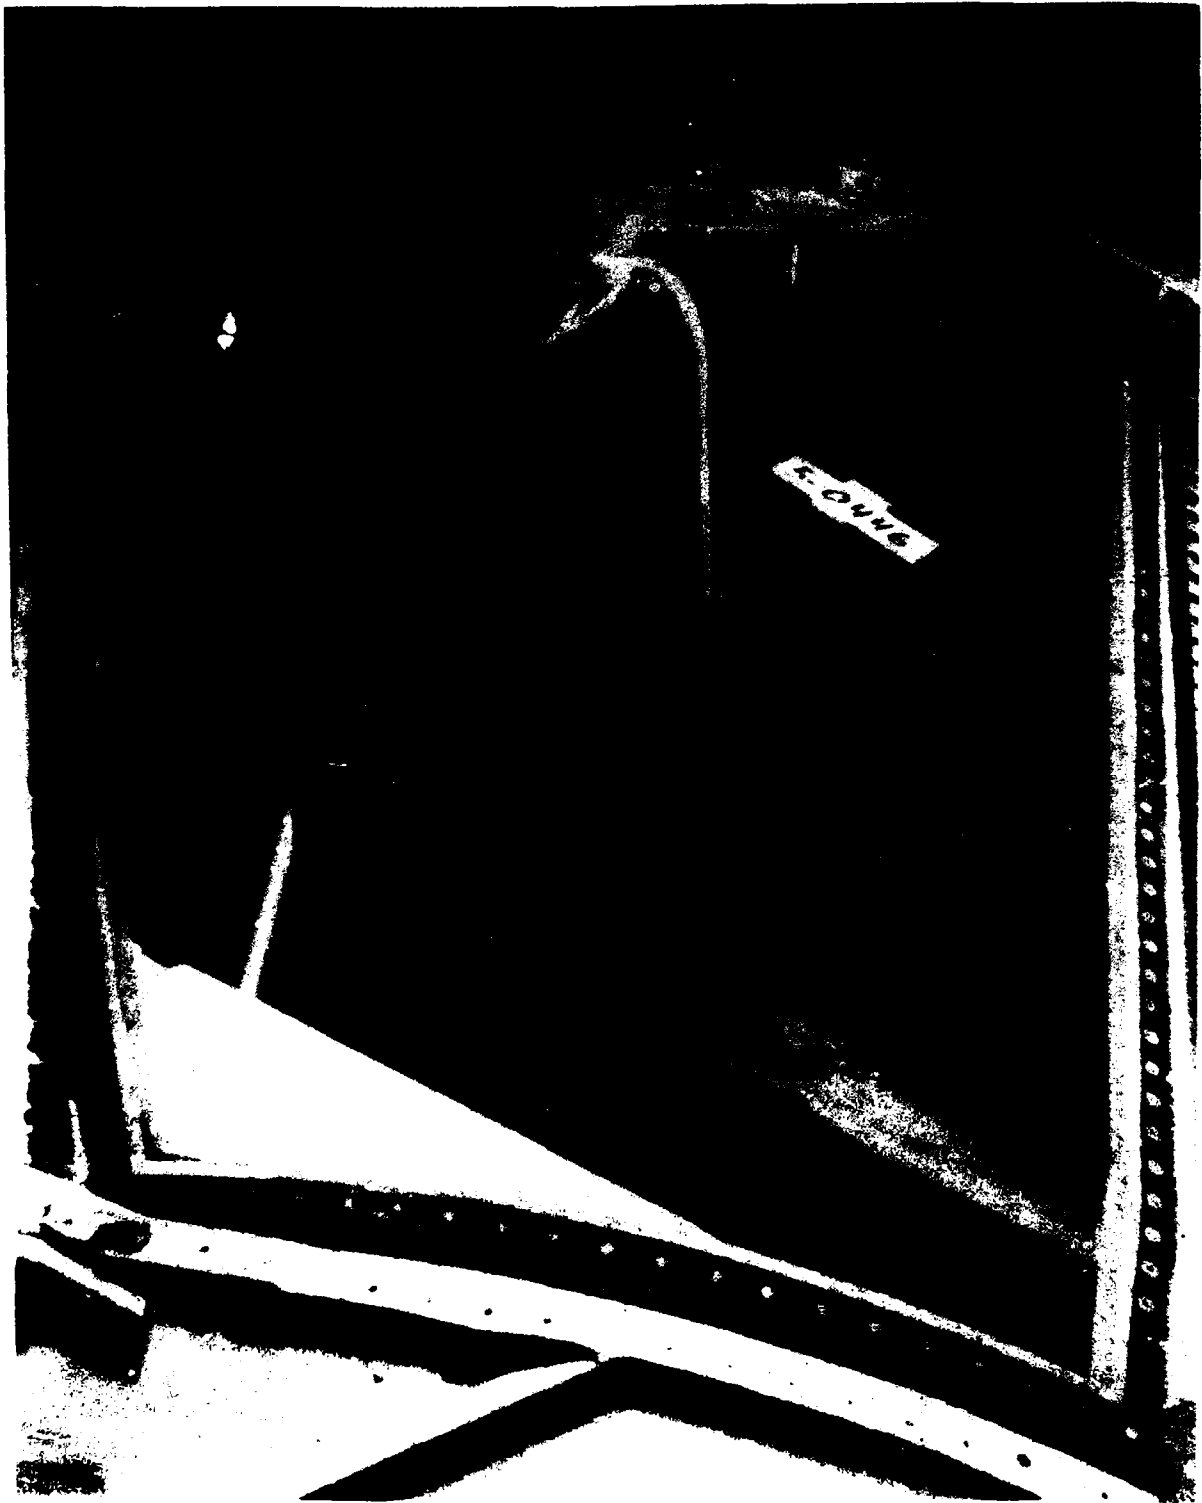
TEST NO. 20 SHOT NO. 5-0446

Acrylic cracked.

Poly cracks in both plies.

Many poly cracks radiating from bolt hole at upper inboard corner.

Failure at 424 knots.

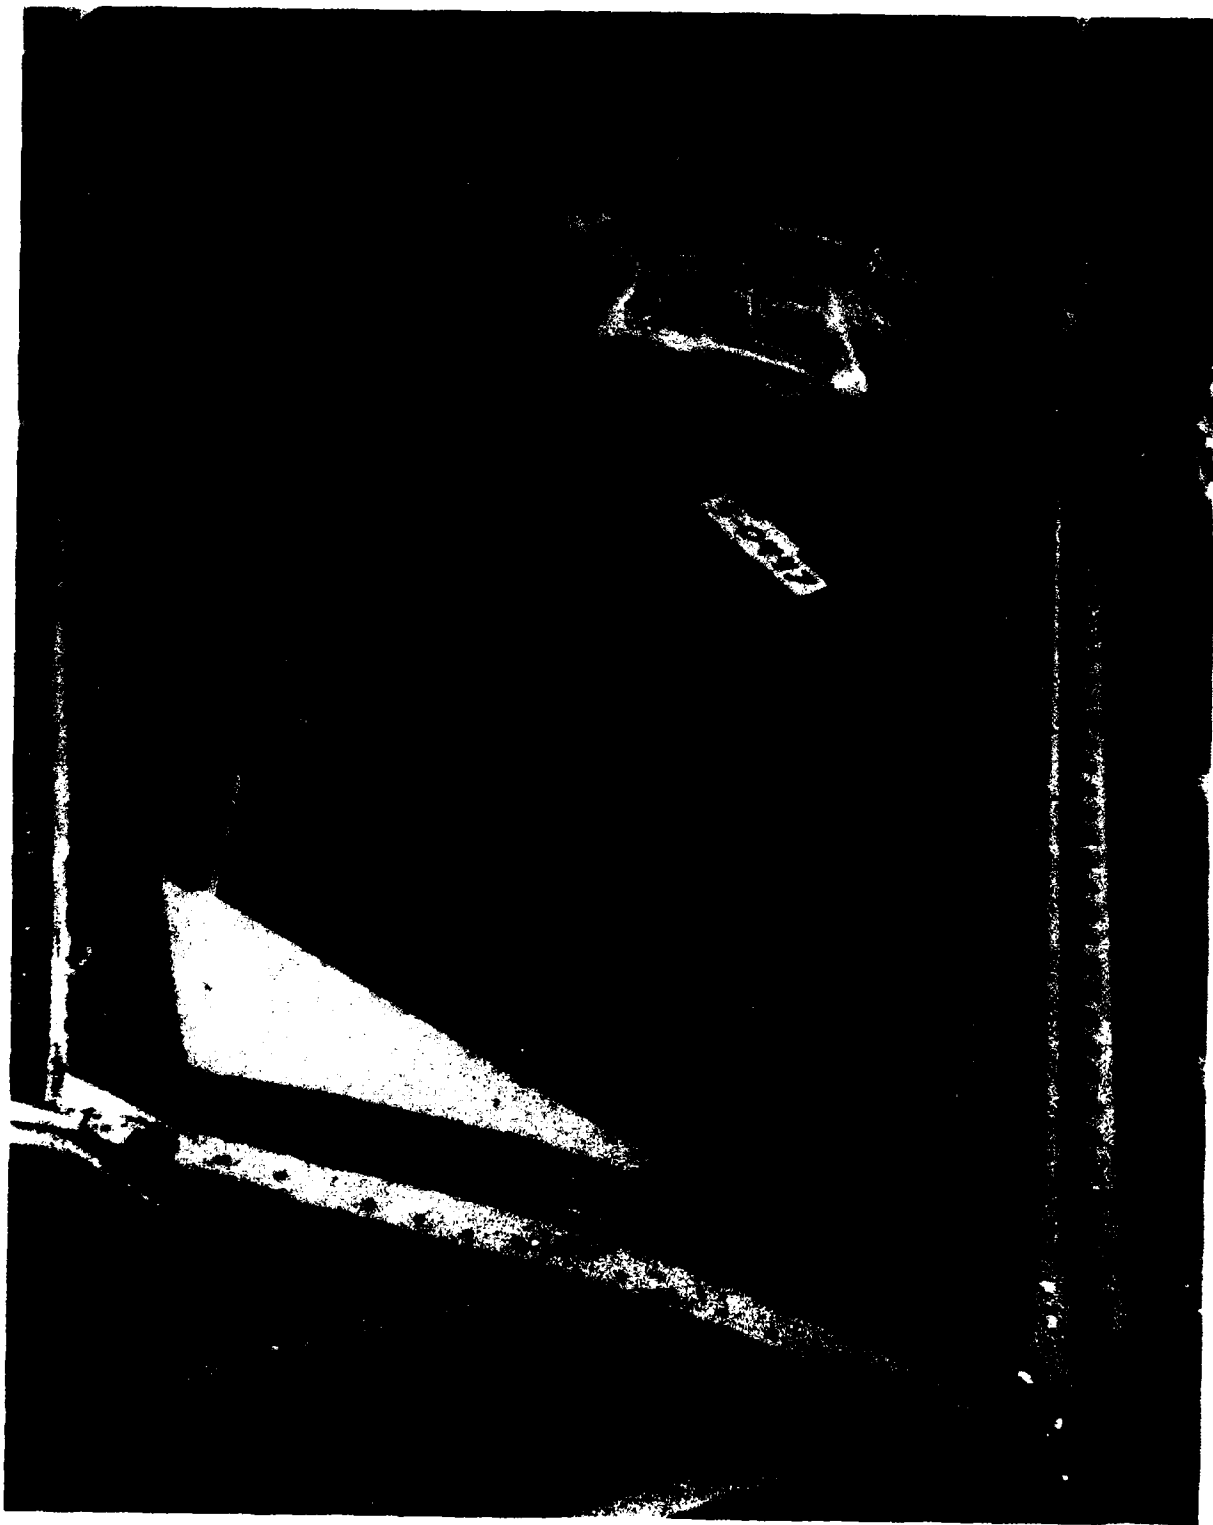
TEST NO. 21 SHOT NO. 5-0447

Moderate acrylic cracking.

Significant polycarbonate cracking, interior ply mostly.

Failure at 383 knots.
